# Home Inspection Report

**435 Springer Drive, Redding CA**

**Riley Johnson, CCI**

**Shasta Home Inspections, LLC**  
**530-945-6292 [Shastainspections@gmail.com](mailto:Shastainspections@gmail.com)**

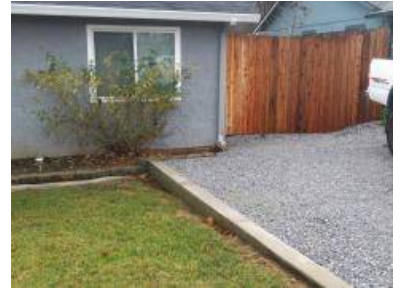
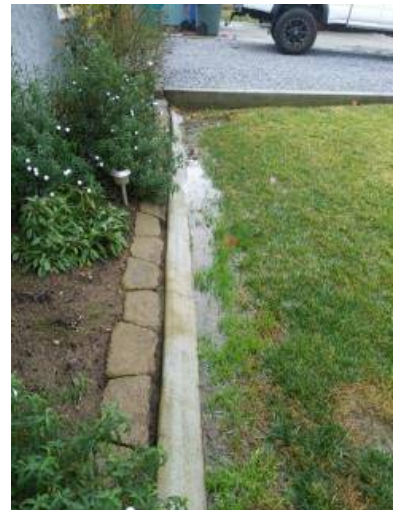
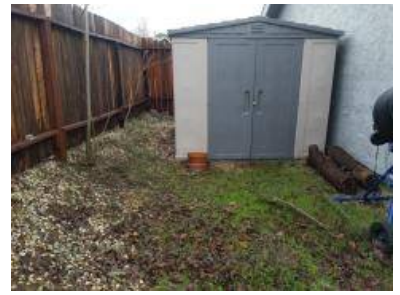
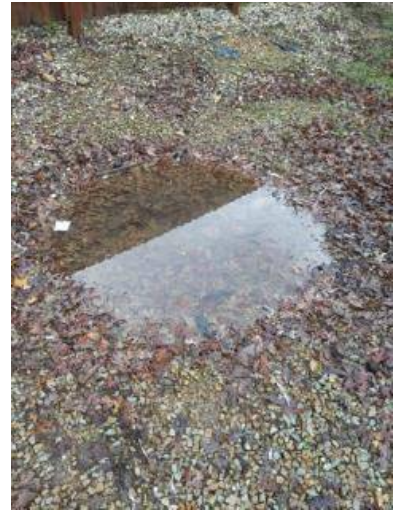
| 216 | SITE GRADING | <p>The grading at the foundation and appeared to be adequate to drain excess surface water away from the building, except where otherwise documented in this report, [CR] The yard grading at areas around the building are not adequately sloped away from or slope towards the building. [CR] Ponding water observed at areas of yard. We recommend installation of additional surface drains and/or grading improvements as necessary. [Note] the lot is lower than adjacent lots. During heavy rains, storm water accumulation on the lot may be unavoidable. This may cause storm water to collect near the structure. Monitor condition during heavy rains.</p> |

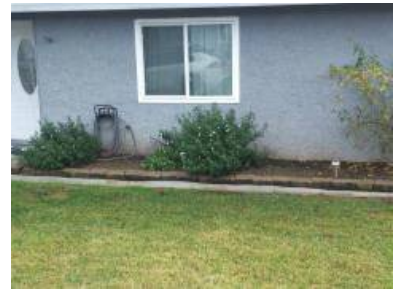
[CR] The raised planter enclosure adjacent to the foundation area has been added, which now raises the soil level at the foundation. This condition is conducive to moisture intrusion and deterioration.

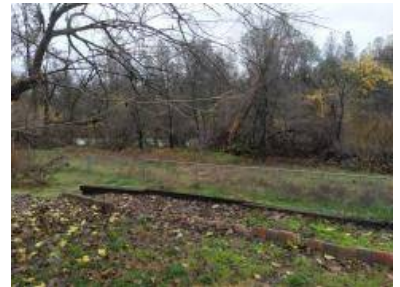
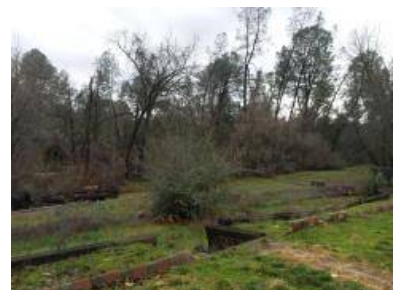
[FE] Seasonal creek present near building. We are unable to determine whether creek is capable of flooding and affecting subject property. We recommend inquiring with seller regarding prior behavior of creek during winter and whether prior flooding has occurred.

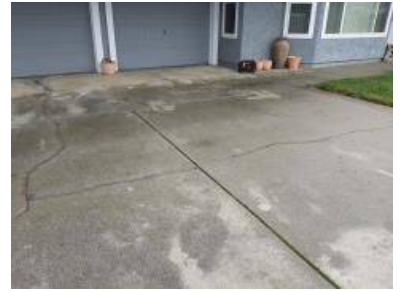
[CR] The driveway drainage is sloped toward the building. This condition is conducive to moisture intrusion and deterioration.

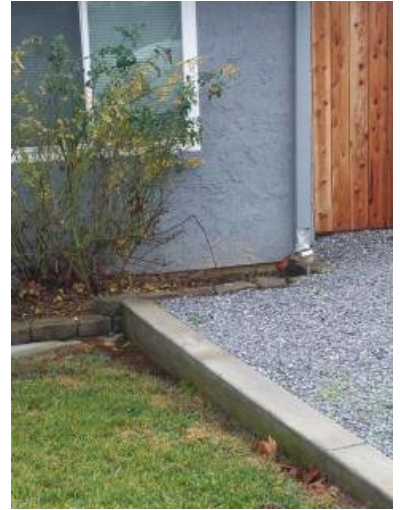
[FE] No surface of underground lot drainage observed. Grading on lot appears to collect storm water at low areas around building. We recommend installation of additional lot drainage provisions.

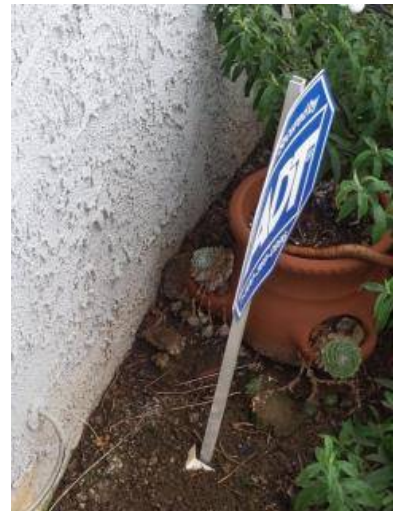
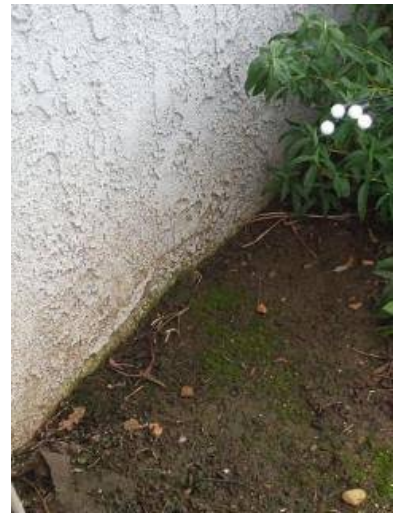
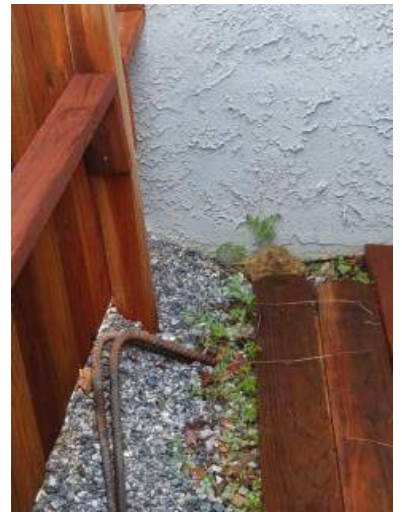
The stucco siding appeared functional, with exceptions. [FE] Portions of the metal stucco weep screed along the bottom edge of the stucco siding lacked adequate clearance from or are buried in the ground. These conditions are conducive to moisture intrusion/deterioration.

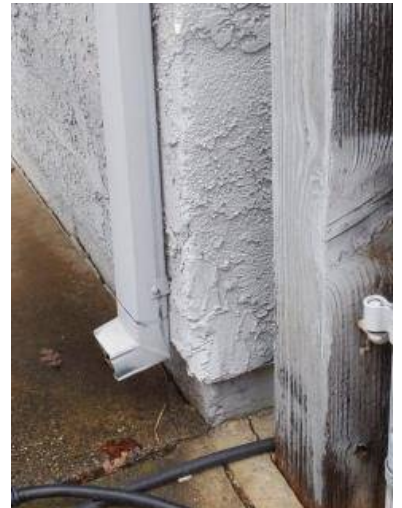
[FE] The stucco siding has past repairs. We recommend inquiring about the condition(s) documented

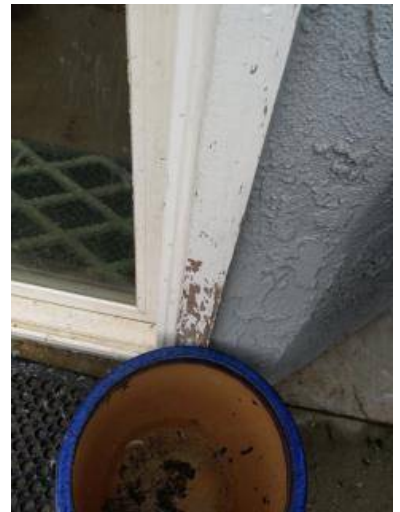
The observed exterior trim materials appeared functional, with exceptions.  
[CR] The trim appears weathered in several areas. Paint is peeling.

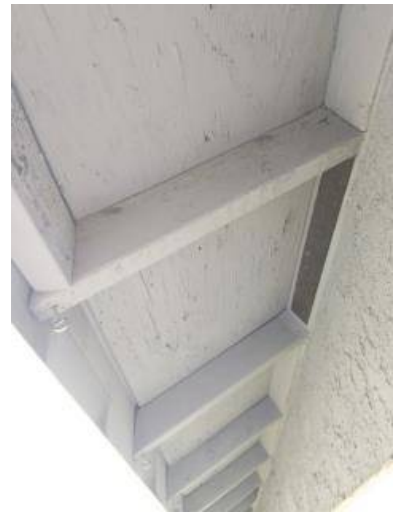
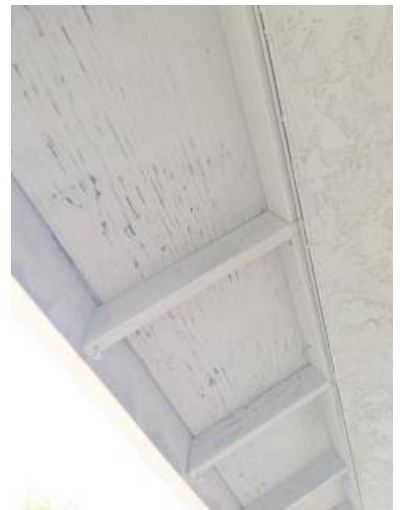
The observed eave and soffit materials appeared functional with exceptions.  
[CR] Peeling paint observed at areas of roof sheathing. This condition may cause premature deterioration of sheathing in these areas.

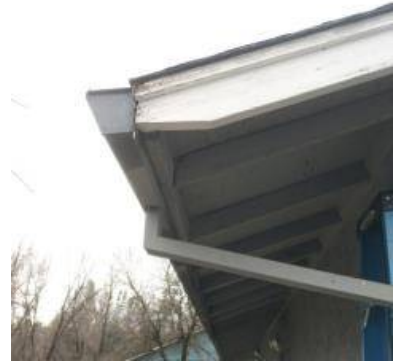
The observed fascia materials appeared functional, with exceptions. [CR] Shingle molding is damaged at localized area.

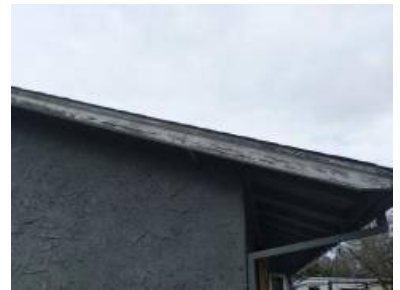
[CR] Areas of the wood fascia appear weathered. Paint is peeling.

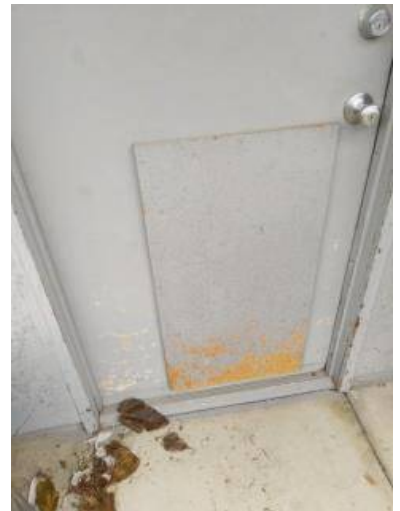
The doors viewed from the exterior appeared functional with exceptions within report. [CR] Wood exterior door is damaged/deteriorated.

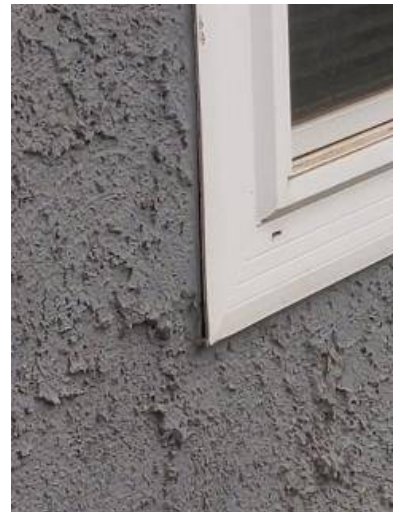
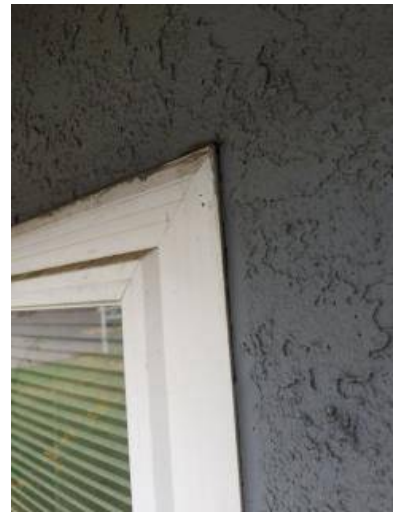
[FE] Retrofit windows have gaps where window frames meet exterior siding.

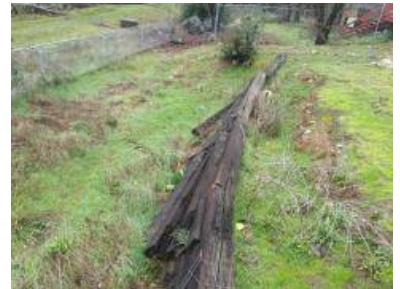
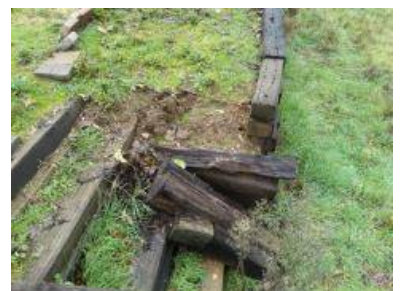
- 256 RETAINING WALL(S)** [FE] These system(s) are outside the scope of the inspection and are not inspected. We recommend consulting with an appropriate professional in the appropriate trade regarding the operation and maintenance of this system. Any comments made are as a courtesy only. [FE] The wood retaining wall(s) are heavily damaged and require replacement. We are unable to determine whether retaining wall has been damaged by adjacent Boulder Creek.

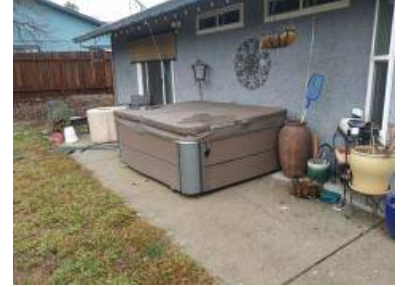
[SC] The spa is capable of holding water more than 24" deep. This condition means that the spa should comply with all pool safety regulations. We recommend that all child safety features comply with the present standards.

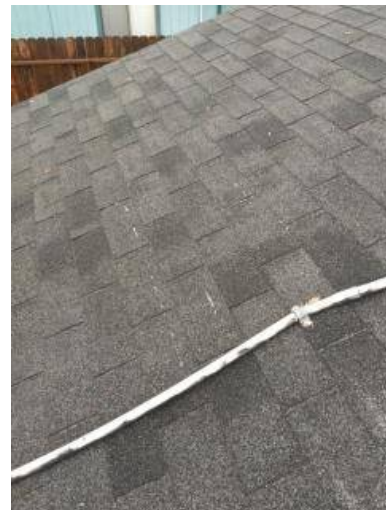
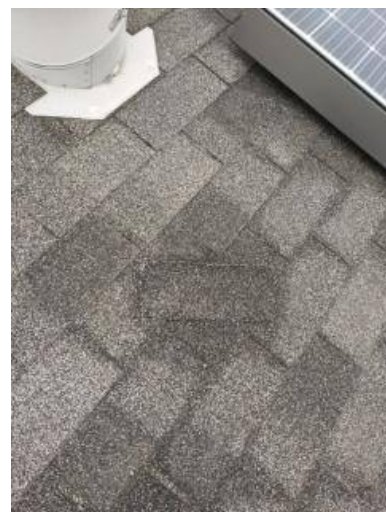
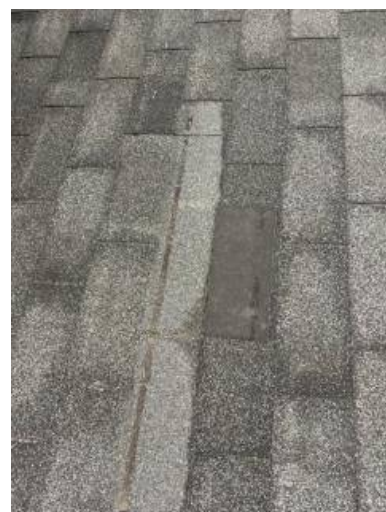
[FE] The shingles have extensive granulation loss, erosion and cracking throughout the shingled surface. There are damaged/missing shingle tabs. Roof is nearing end of useful life. Prior repairs/sealing noted at composition roofing. This often indicates past problems or leaks. Recommend full evaluation by a licensed roofer.

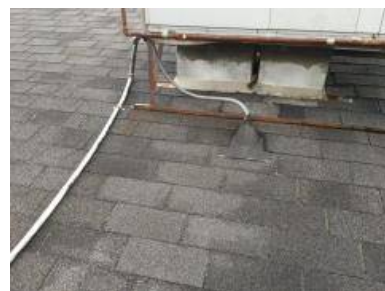
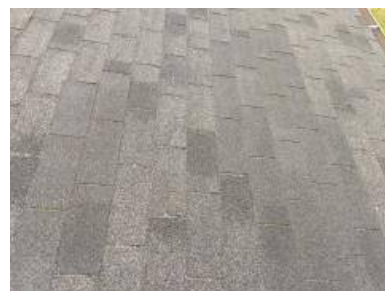
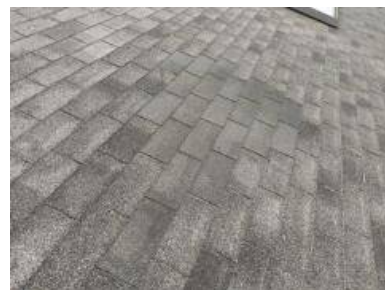
[FE] Prior repairs noted at composition roofing. Newer shingles observed at localized area. This often indicates past problems or leaks.

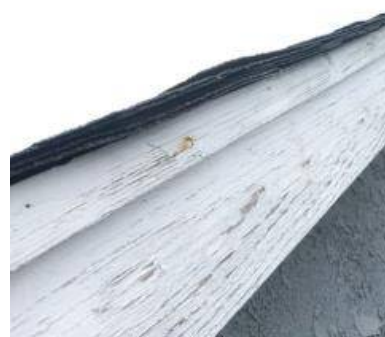
Note: Composition roof is an overlay. Prior layer of roofing is installed beneath visible layer. When visible roof layer requires replacement, both layers must be removed prior to roof replacement. This may add significant cost to the roof replacement.

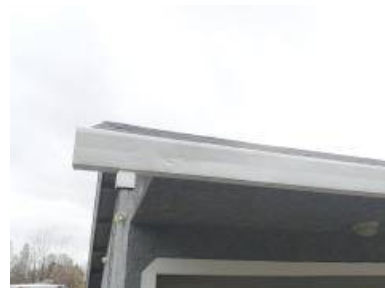
[CR] Gutters are bent/damaged in pictured area.

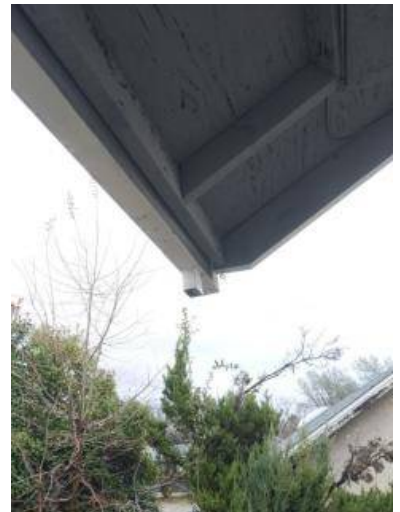
[CR] There are missing downspouts.

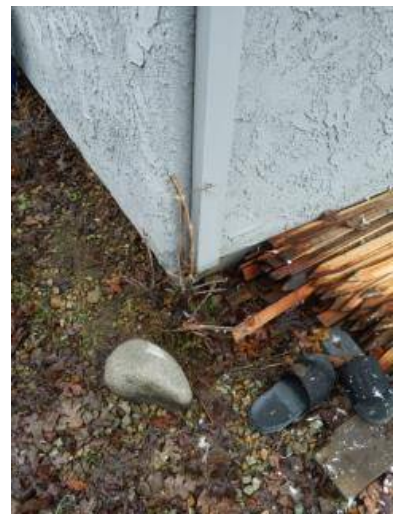
[CR] The downspout kick-out elbow is damaged/missing.

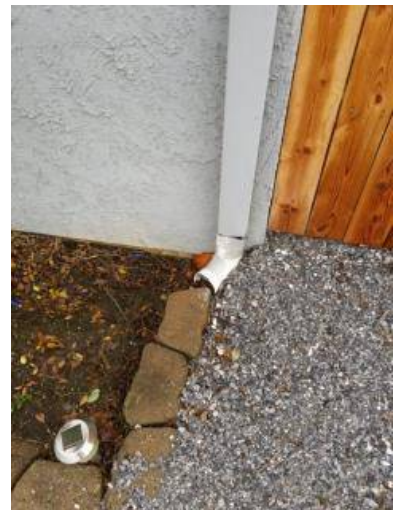
[CR] Runoff water from the roof discharged next to the building. We recommend the downspouts be routed sufficiently away from the building to prevent ponding, pooling, and saturation of the soil at the foundation.

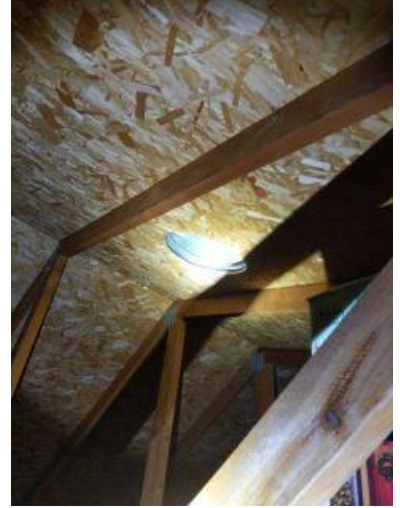
[FE] The pictured garage turbine vent/flashing is leaking. Water is puddling on board in attic laying across ceiling joists. Prior drywall repairs observed in this area.

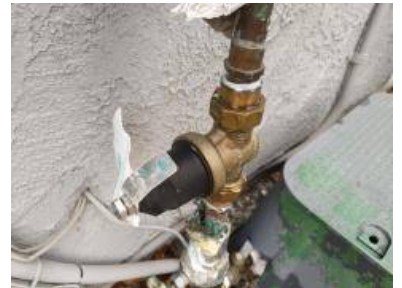
| 507 WATER PIPING | The observed water supply piping appeared functional. Water pressure at an exterior hose faucet tested at 65 psi.<br>[CR] Water supply pipe leak noted near regulator/shutoff. Exact source was not determined due to recent rain. |

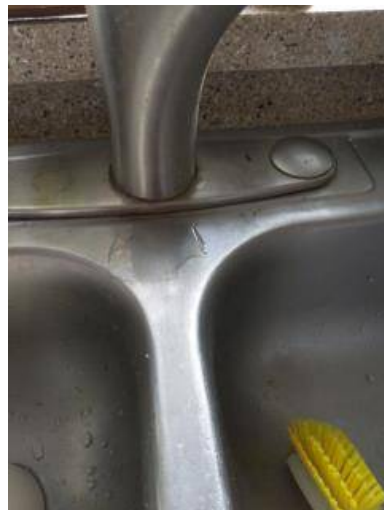
[CR] The faucet leaks at the underside of the fixture.

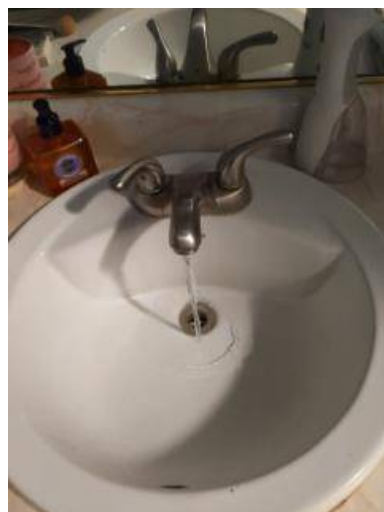
[CR] The sink stopper is damaged/defective/missing parts.

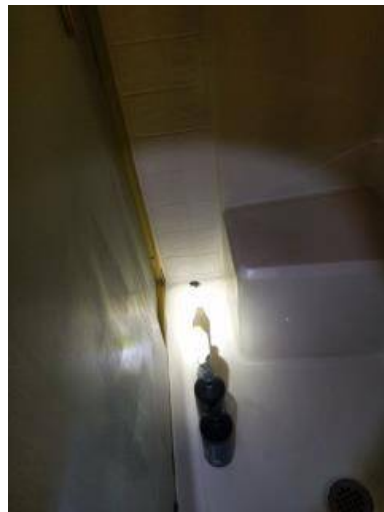
The tub/shower appeared functional, with exceptions. [CR] Chips/cracks observed in the fiberglass tub/shower.

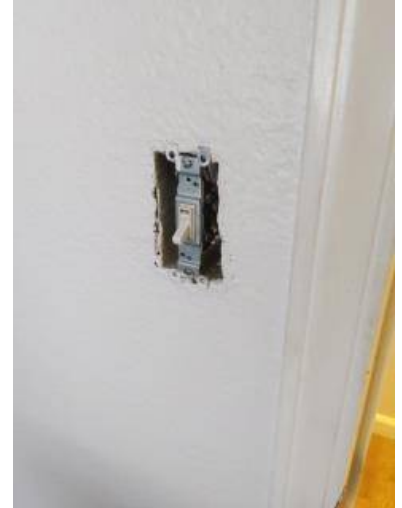
- 625 SWITCHES The accessible switches are functional with exceptions.  
Switch(s) are damaged/missing.

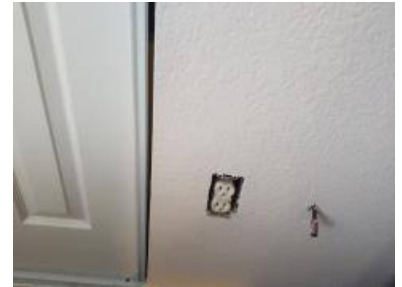
- 627 GROUNDED RECEPTACLE(S) The accessible receptacles are functional with exceptions.  
[CR] Receptacle cover plates are missing.

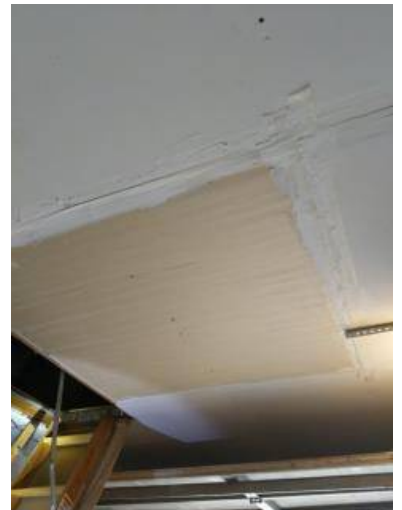
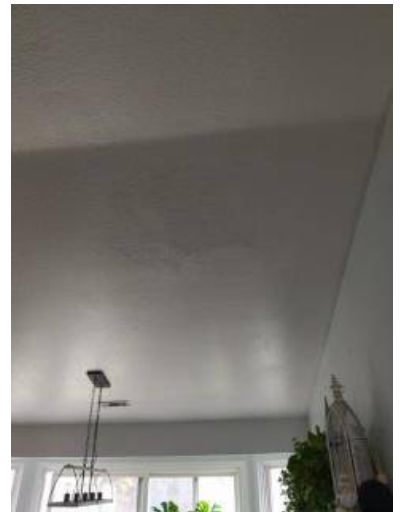
- 907 WALL(S)/CEILING(S) The observed areas of the walls and ceiling appeared functional with exceptions.  
[FE] Prior drywall repairs observed.

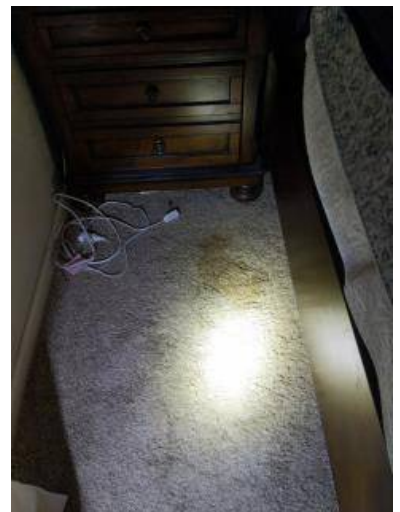
- 908 CLOSET(S)** The closets are functional.
- 909 CARPET FLOORING** The observed areas of the carpet appeared functional with exceptions.  
[CR] The carpet is soiled/stained.

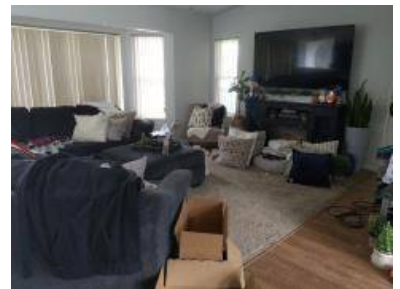
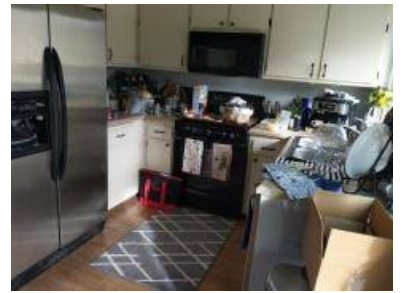
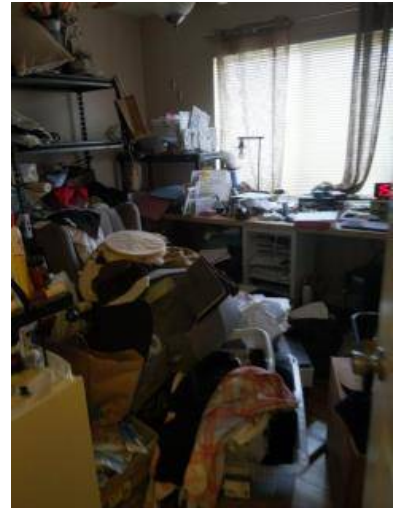
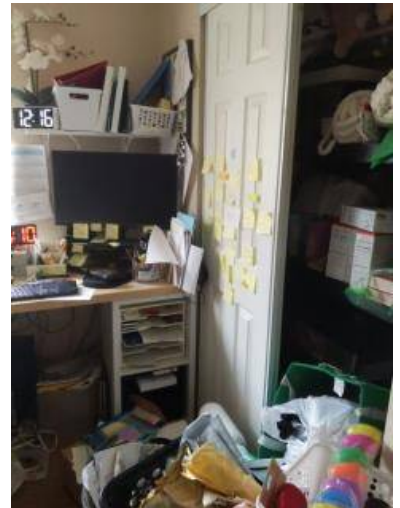
- 913 LAMINATE FLOOR(S)** The observed areas of the laminate floor appeared functional.
- 914 COMMENTS:** [FE] Pet odor observed in building. This may be due to pet waste in the floor coverings/baseboards/wall surfaces. We recommend a full evaluation and/or corrections by an appropriate professional in the appropriate trade.  
[FE] Large quantity of stored items in home prevent evaluation of wall and floor surfaces.

Note: new interior paint observed. This may conceal prior repairs/patching/stains.

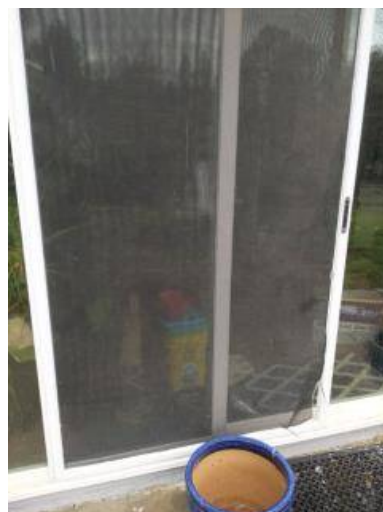
- 916 EXTERIOR DOOR(S)** The door(s) are functional with exceptions.  
[CR] The screen door(s) have damaged mesh.

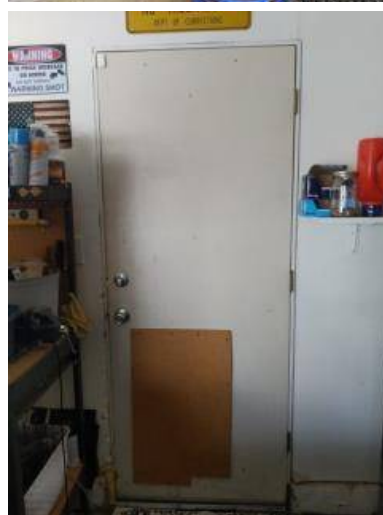
[CR] Door casing/trim is not installed.

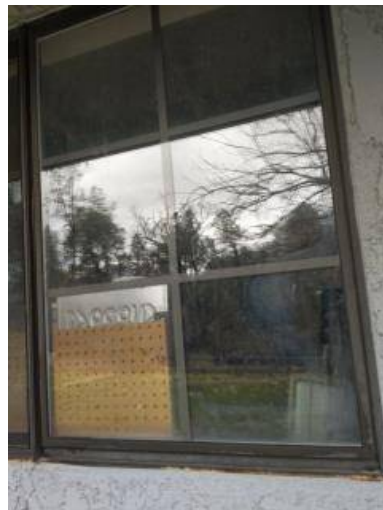
- 917 WINDOW(S)** The accessible window(s) are functional with exceptions.  
[FE] Condensation/stains observed between the glass panes in the thermal window(s). We recommend having all of the doors and windows evaluated by an appropriate professional in the appropriate trade.

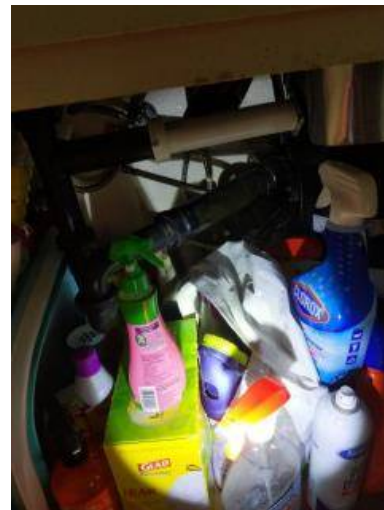
The cabinet(s) are functional with exceptions. [FE] There is moisture staining and damage in the kitchen cabinet. We recommend locating and correcting the source and any damaged materials.

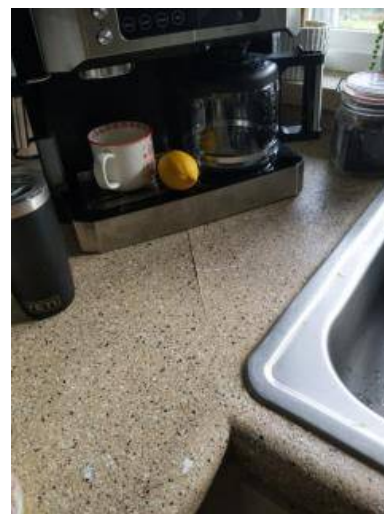
[CR] Laminate kitchen counter top has moisture-related damage.

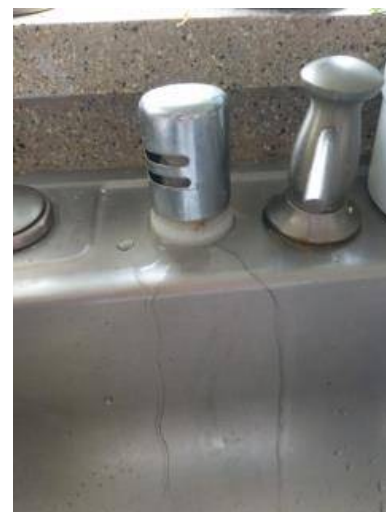
The dishwasher(s) functioned with normal controls. Washing performance and filters/internal components are not evaluated.  
 [CR] Leakage observed at the air gap device.

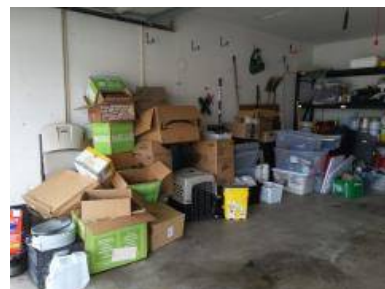
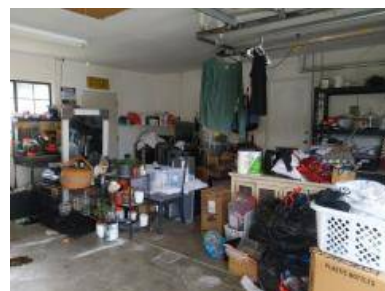
- 971 GARAGE FLOOR(S) [FE] The floor is not fully observable, due to stored items. We recommend checking these areas after the stored items are removed.

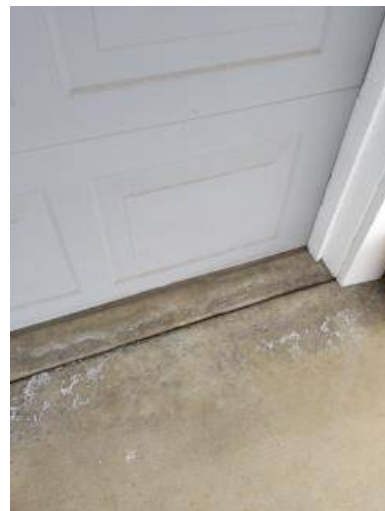
- 972 GARAGE DOOR(S) The garage door(s) were operated and appeared functional, [CR] The garage door is damaged/warped/bent.

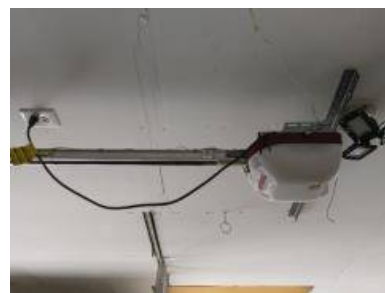
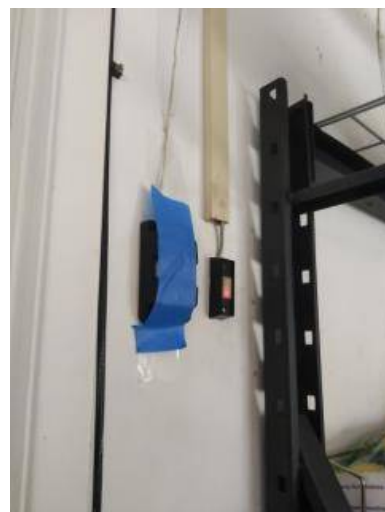
[CR] The garage door opener(s) failed to function. Button was taped over and door was obstructed by stored items.

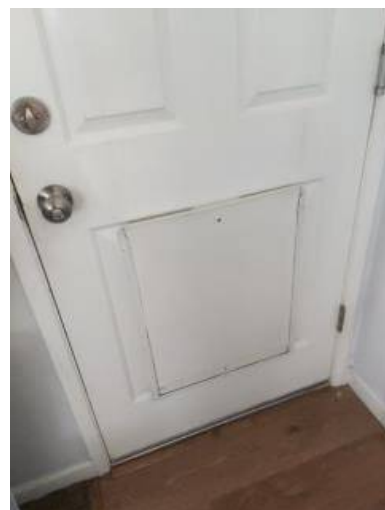
[SC] A pet access is installed in the fire-resistant door. This condition is a breach in the fire-resistive wall.
