# Home Inspection Report

**3411 Lemurian Road, Redding CA**

**Riley Johnson, CCI**

**Shasta Home Inspections, LLC**  
**530-945-6292 [Shastainspections@gmail.com](mailto:Shastainspections@gmail.com)**

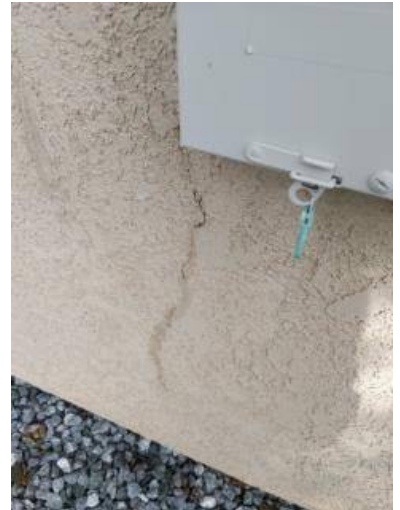
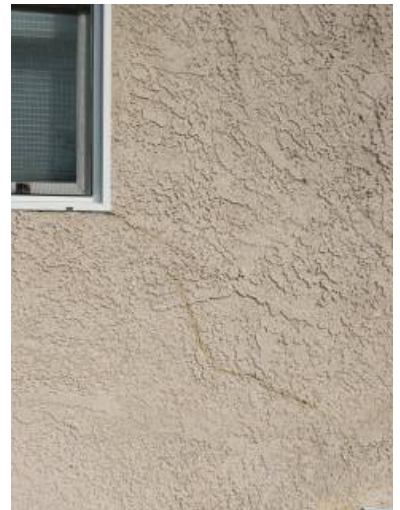
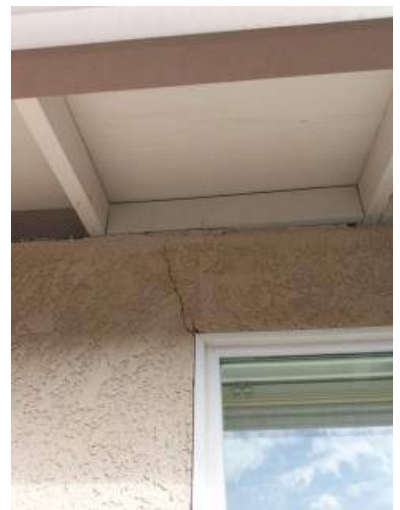
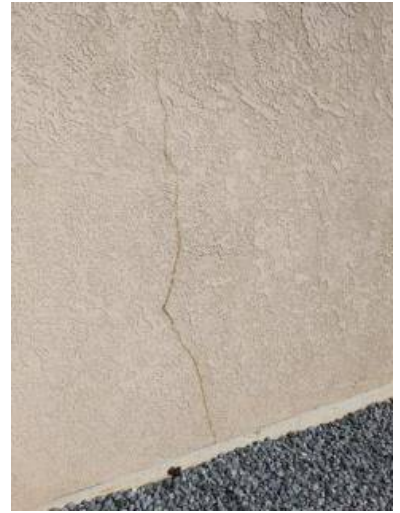
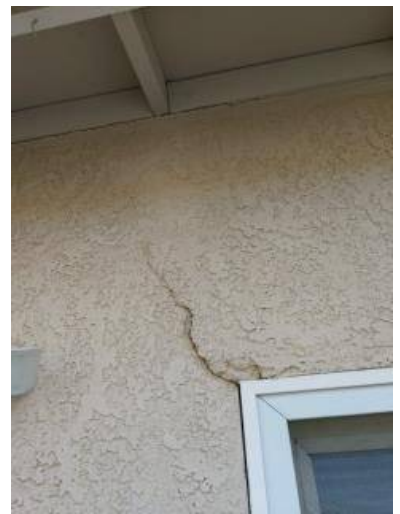
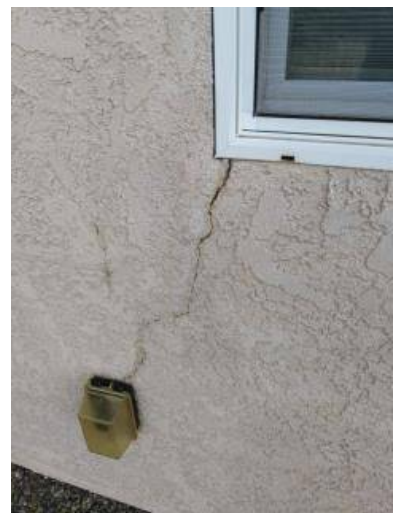
- 238 STUCCO CLADDING** The stucco siding appeared functional, [CR] Cracks observed in areas of the stucco siding. Cracks are improperly sealed with silicone-type sealant. Recommend sealing with appropriate product.

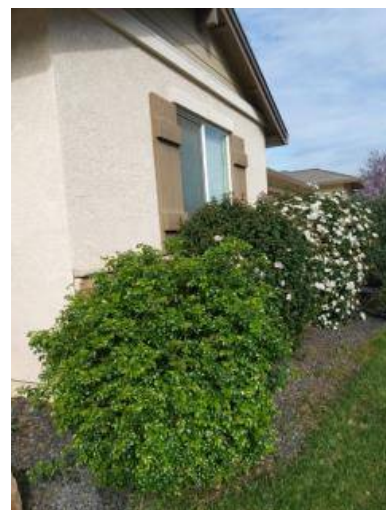
[\[CR\]](#) Maintenance, trimming or removal of vegetation is needed at areas of the property to prevent overgrowth and encroachment onto the building.

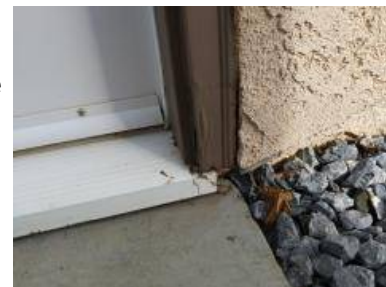
The doors viewed from the exterior appeared functional with exceptions within report. [CR]  
Exterior wood door frame(s) damaged near base of frame.

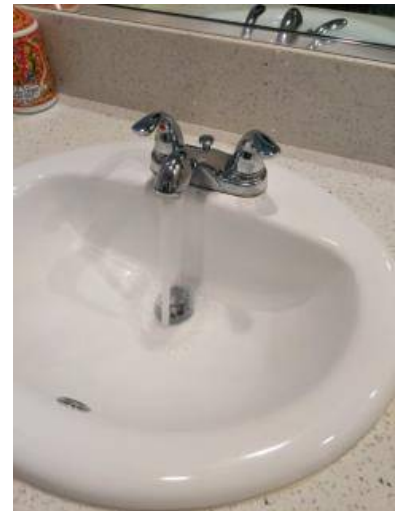
- 512 SINK FAUCET(S)** The faucets and piping appeared functional.
- 513 HOSE FAUCET(S)** The accessible hose faucets are functional.
- 514 SINK(S)** The observed and accessible sinks appeared functional.
- 515 TOILET(S)** The toilets functioned.
- 518 TUB(S)/SHOWER(S)** The tub/shower appeared functional, with exceptions. [\[CR\]](#) The stopper mechanism is defective/missing parts.

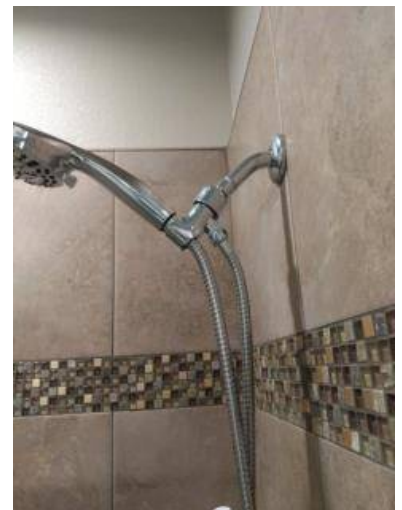
[\[CR\]](#) The flexible shower sprayer hose is leaking at fittings.

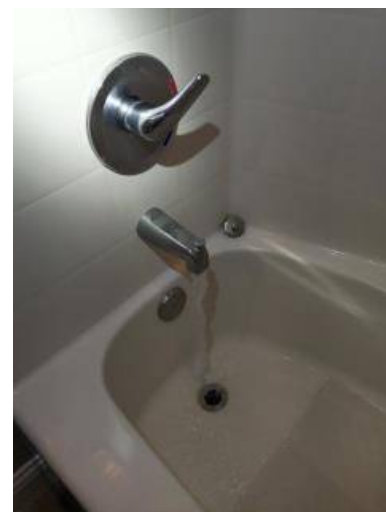
[CR] The stopper mechanism is defective/missing parts.

[CR] The bath/shower handle is loose.

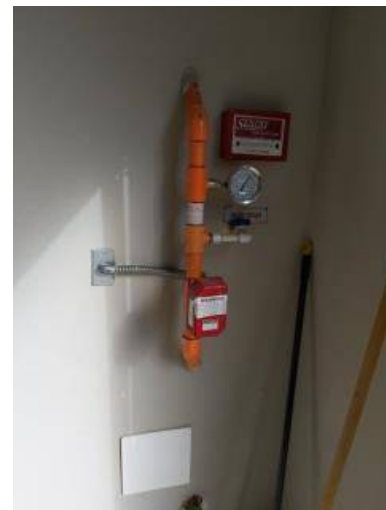
### 553 FIRE SPRINKLER(S)

[FE] These systems are outside the scope of the inspection and are not inspected. We recommend consulting with an appropriate professional in the appropriate trade regarding the system's operation and maintenance. Note: These systems require regular inspections and testing every 5 years. We recommend consulting with an appropriate professional in the appropriate trade regarding the system's maintenance.

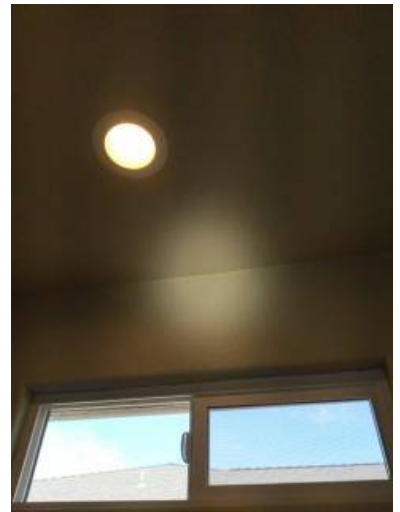
- 907 WALL(S)/CEILING(S)** The observed areas of the walls and ceiling appeared functional with exceptions.  
[FE] Prior drywall repairs observed.

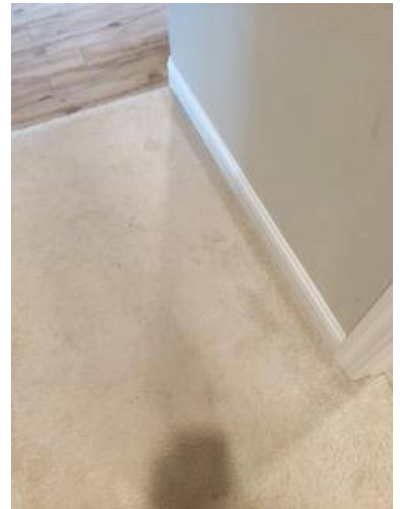
- 908 CLOSET(S)** The closets are functional.
- 909 CARPET FLOORING** The observed areas of the carpet appeared functional with exceptions.  
[CR] The carpet is soiled/stained.

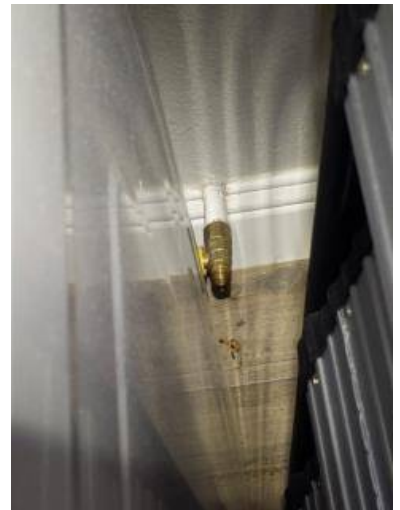
- 963 WASHER SERVICE** The laundry faucets appear functional, no leaks observed, a machine is connected. We do not operate the faucets. Note: water supply lines/valves are not evaluated. Appliances are not moved during the inspection. Wall and floor surfaces concealed by appliances are not evaluated. Operation of laundry appliances is outside the scope of this inspection.
- 964 DRYER SERVICE** There is both gas and 220 volt electric hookups for a dryer. **[SC]** Gas line is not capped at the shutoff valve/connector.

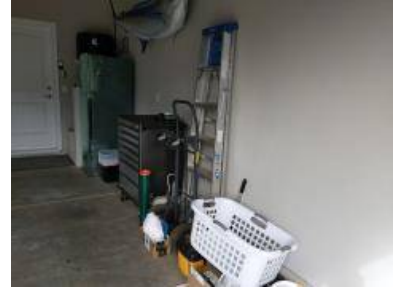
- 971 GARAGE FLOOR(S) The observed areas of the garage floor appeared functional with exceptions.  
 [FE] The floor is not fully observable, due to stored items. We recommend checking these areas after the stored items are removed.
