# Home Inspection Report

**435 Springer Drive, Redding CA**

**Riley Johnson, CCI**

**Shasta Home Inspections, LLC**  
**530-945-6292 [Shastainspections@gmail.com](mailto:Shastainspections@gmail.com)**

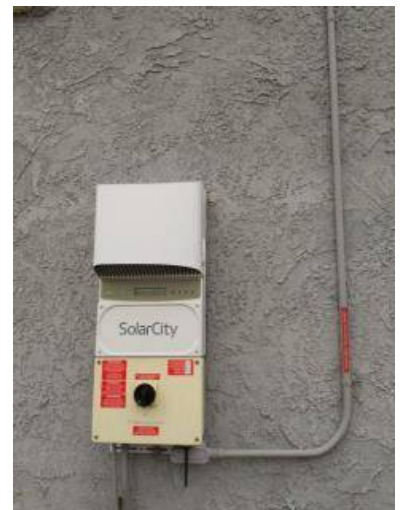
- 634 SOLAR PANELS AND RELATED EQUIPMENT [FE] These system(s) are outside the scope of the inspection and are not inspected. We recommend consulting with an appropriate professional in the appropriate trade regarding the operation and maintenance of this system. Any comments made are as a courtesy only.
